Hydraulic Engineering Repository

Ein Service der Bundesanstalt für Wasserbau

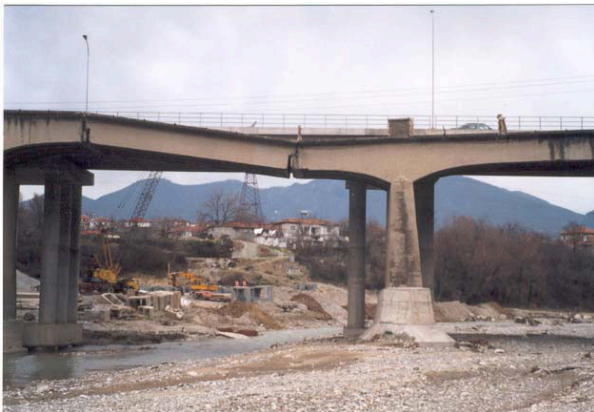
Photo nr. 1. Peshkatari bridge. It's looking to east, and shows, cracks, destroyed beam and a sinking of pier.

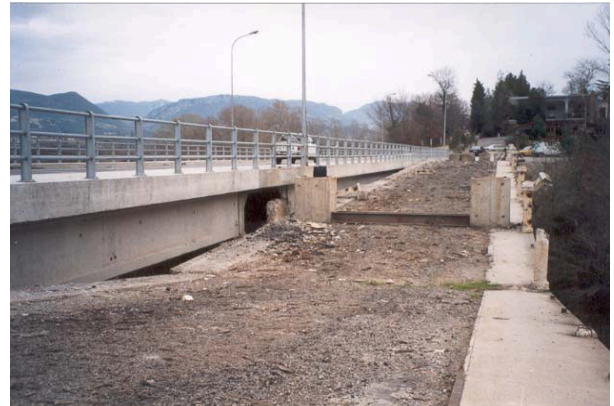
Photo nr. 2. Peshkatari bridge. It's looking to south, and shows, the new bridge and the destroyed bridge (right side) which is sunken 1.98 m compared with the new bridge.

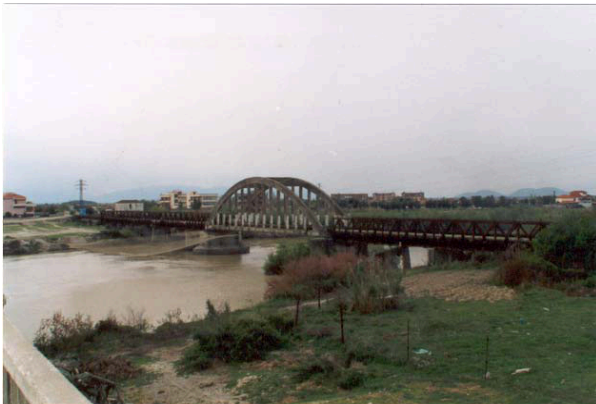
Photo nr. 3. Mifoli bridge. It's looking to north-east, and shows, its structure

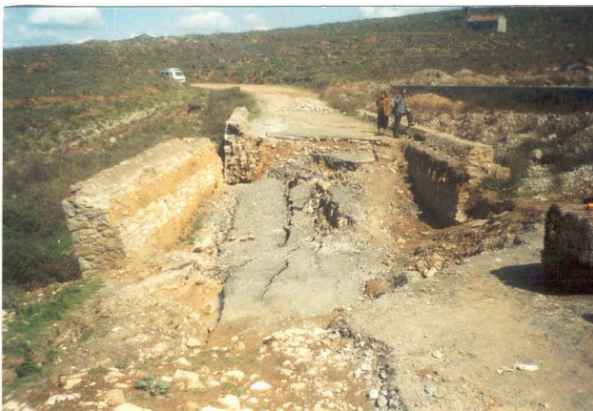
Photo nr. 5. Kallmeti bridge. It's looking to north, and shows, the sinking of its pillars and pavement

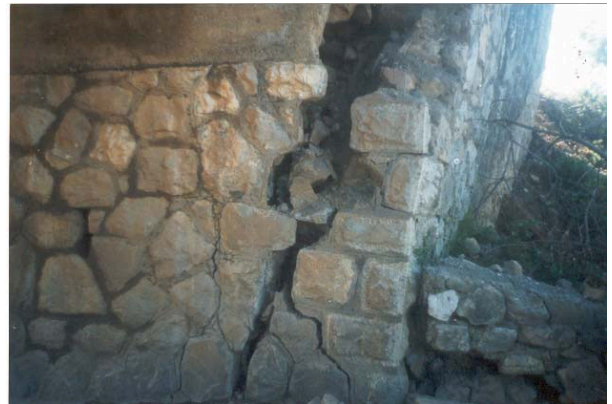
Photo nr. 6. Kallmeti bridge. It shows cracks of pillars from erosion phenomenon

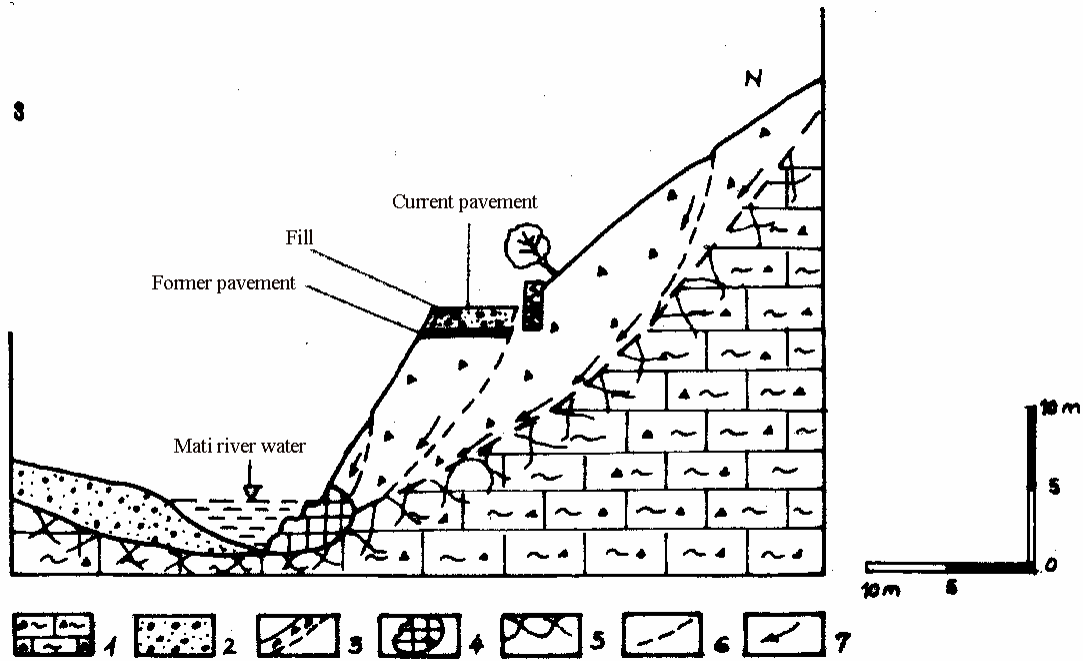
Fig. 3 Cross section of Shkopeti landslide
