Conference Paper, Published Version

**Chiew, Yee-Meng**

## **Failure Mechanisms of Riprap Layer Around Bridge Piers**

Chiew, Yee-Meng (2002): Failure Mechanisms of Riprap Layer Around Bridge Piers. In: Chen, Hamn-Ching; Briaud, Jean-Louis (Hg.): First International Conference on Scour of Foundations. November 17-20, 2002, College Station, USA. College Station, Texas: Texas Transportation Inst., Publications Dept.. S. 70-91.

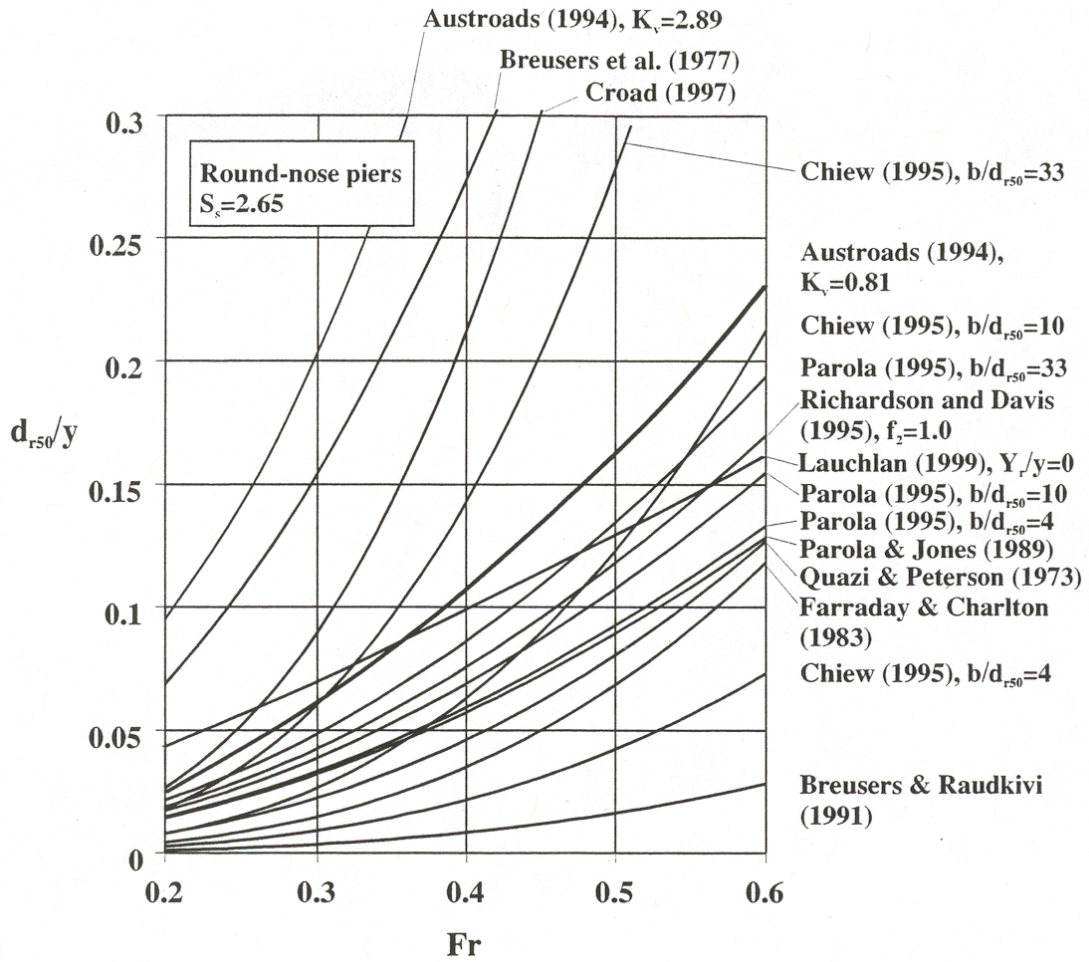
Figure 1. Comparison of Equations for Sizing Riprap at Bridge Piers  
(Melville and Coleman 2000)

A comparison of these 12 equations was done by Lauchlan (1999), and is reproduced in Figure 1. Although researchers in the area of the pure sciences may be appall with the lack of consistency of the data, researchers in sediment transport area is not unfamiliar with such variations. In fact, when compared with other sediment transport predictive equations, the bulk of the equations do give reasonably consistent results.

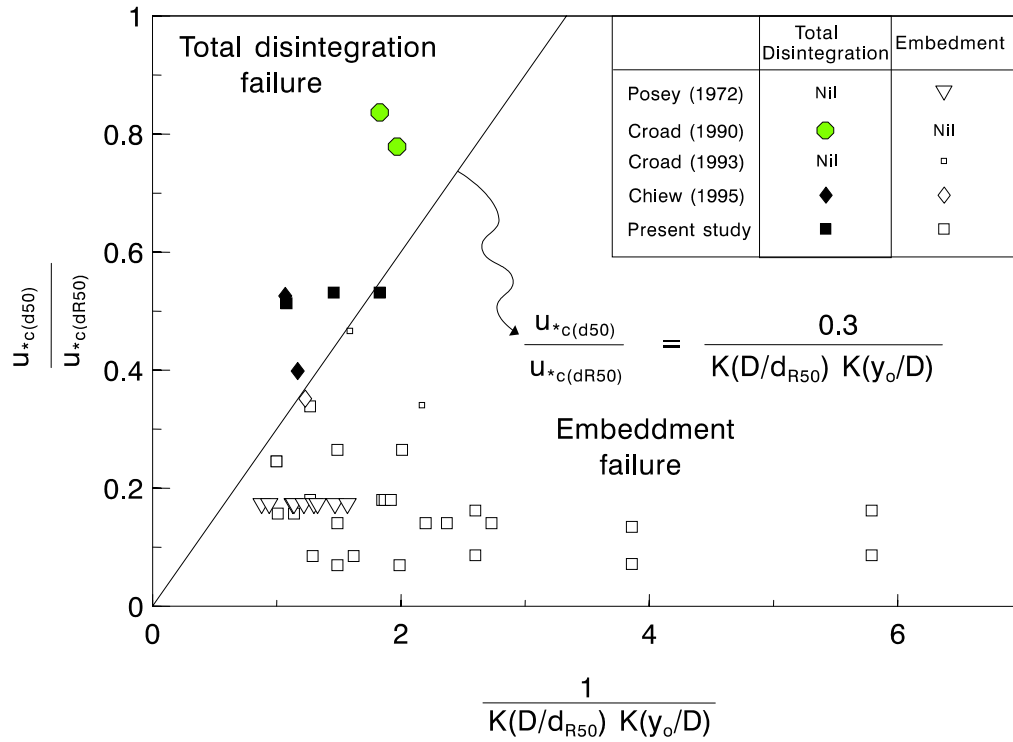
Figure 2. Classification of Failure Mode of riprap Layer (Chiew and Lim 2000)

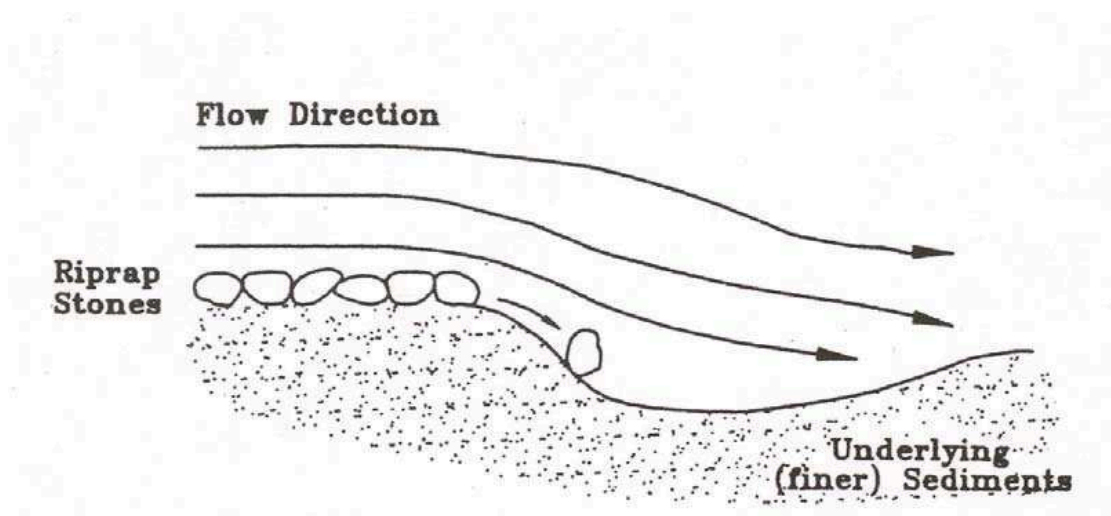
Figure 3. Schematic Illustration of Edge Failure (Chiew 1995)

The third type of failure associated with riprap protection around bridge pier is edge failure. This occurs at the periphery of the coarse riprap stones and fine bed sediment interface. Chiew (1995) first documented this type of failure, and attributed it to the increase in shear stress on the finer sediment bed as water flows from the coarse to the fine bed boundary. It is not uncommon in flume experiments involving a rigid-loose bed interface. At such a location, a scour hole inevitably forms on the downstream erodible bed.

With riprap protection around a bridge pier, edge failure can occur when the coarse riprap stones remain intact; i.e., they can resist shear failure. With the intact riprap layer in place, the downstream finer sediment particles are entrained by the flow because of their lower critical shear stress. When this happens, a local depression forms, exposing the larger riprap stones. The stones at the edge thus roll or slide into the depression, as illustrated in Figure 3. Chiew (1995) observed the occurrence of edge erosion at the downstream end of the riprap layer. Such erosion takes place at low velocity ratio where shear

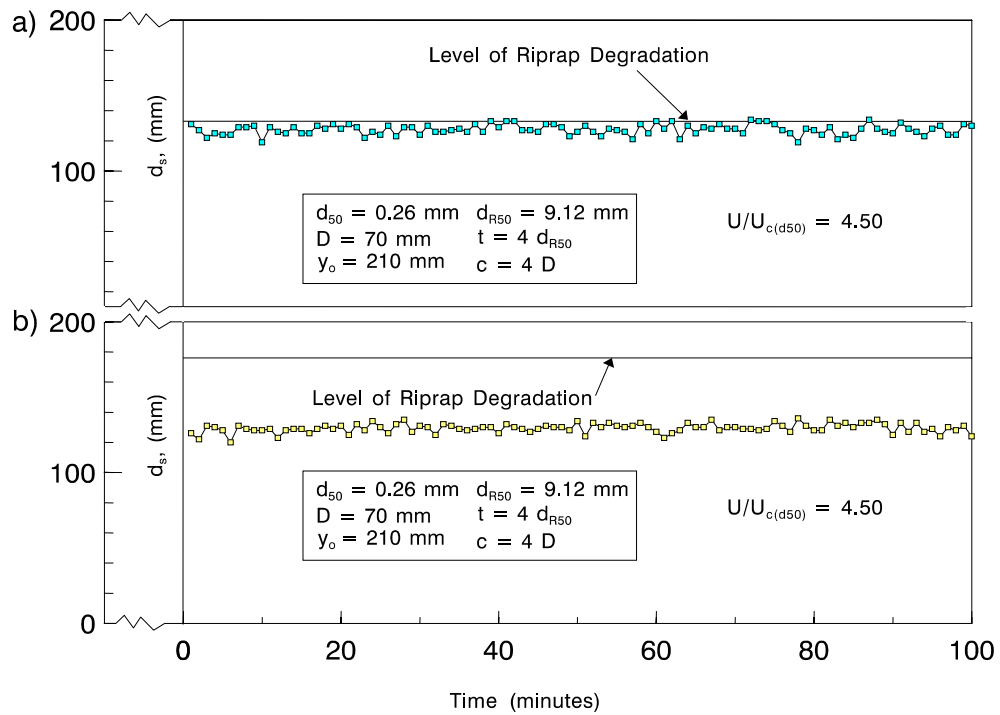
Figure 4. Temporal Variation of Scour Depth in Transition Flat Bed Regime with Different Antecedent Bedforms: (a) Immobile Plane Bed; (b) Immobile Plane Bed, Ripples and Dunes (Chiew and Lim 2000)

Chiew and Lim (2000) have also devised an experiment to distinguish bedform-induced failure from the other three types of failure. It includes two tests which were both conducted under transition flat bed conditions at a velocity ratio,  $U/U_c = 4.5$ . All the other conditions for both the tests were identical except that in the first test, the flow velocity was increased as quickly as practicable so that transition flat bed was formed immediately after the onset of the test. The objective of such a procedure was to avoid the formation of ripples or dunes on the approaching bed so as to negate any bedform-induced failure at the riprap layer before the test was conducted. With the second test, velocity was increased incrementally to allow ripples and dunes to form prior to the final test with  $U/U_c = 4.5$ .

Figure 4 shows the results of the two tests, and it depicts the temporal scour depth fluctuation at  $U/U_c = 4.5$  where transition flat bed was present on the approaching bed. The horizontal lines in Figures 4(a) and 4(b) represent the depth of the riprap layer – the level at which the riprap layer has degraded. The results show that the levels of riprap degradation,  $d_{rp}$  for Test 1 and 2 are 133 mm and 176 mm, respectively. In Test 1, the scour depth expectedly fluctuates with time and it is due to avalanches of the sediment particles on the upstream slope of the scour hole. It shows that the riprap layer has clearly degraded to the same level as the maximum scour depth. On the other hand,  $d_{rp}$  associated with Test 2 is deeper than the observed maximum scour depth at  $U/U_c = 4.5$ . The reason for the deeper  $d_{rp}$  is because of the antecedent condition where ripples and dunes were allowed to form before the later test was conducted. The differential of 43 mm (difference between 176 and 133 mm) is caused by bedform-induced failure.

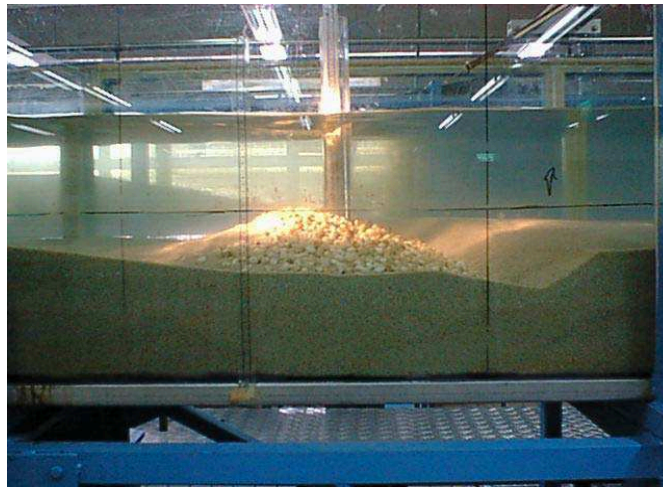
Figure 5. Formation of riprap mound around bridge pier in a degrading bed (Flow from right to left)

The cumulative effect of these two features is the formation of a stable mound consisting of riprap stones around the bridge pier, as is shown in Figure 5. Chiew (2002) further showed that the riprap mound might be susceptible to failure when it is subjected to another flood accompanied by large dunes.

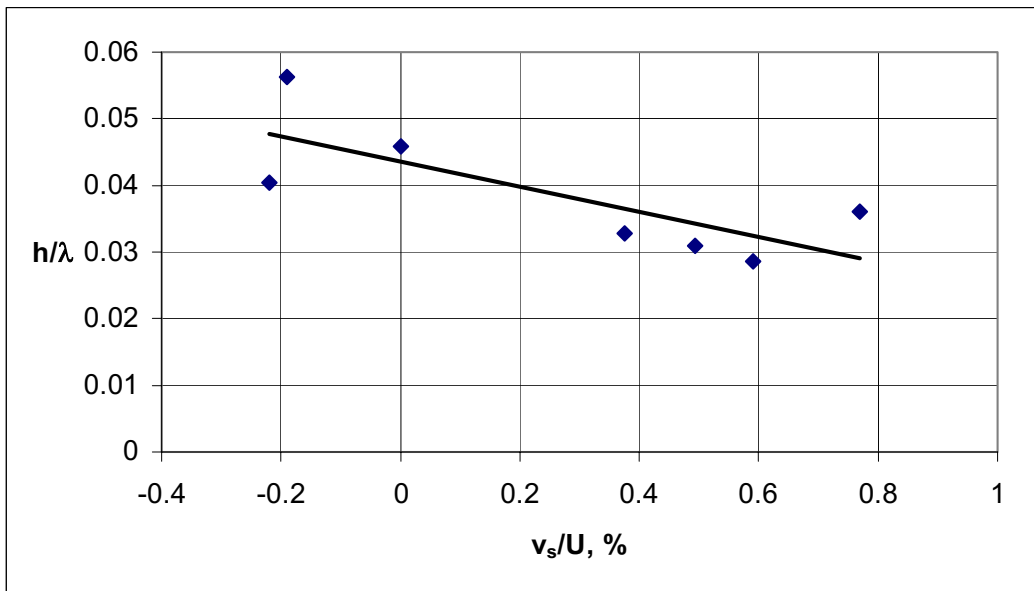
Figure 6. Effect of relative seepage velocity on dune steepness

To this end, the present writer has conducted some very preliminary studies on seepage effect on dune geometry. These data are encouraging in that the dune geometry does appear to change as bedforms translate past a region subjected to upward seepage or suction. Previous studies on both seepage and suction (Cheng and Chiew, 1998; 1999 and Chen and Chiew, 2001) have shown a close correlation between such flows on the turbulence characteristics of the main flow field. This, in turn, affects the sediment transport behavior of the river. It, therefore, would not be inappropriate to surmise that either seepage or suction could have a positive influence in reducing the size of the dunes. Figure 6 shows the preliminary results of the effect of relative seepage velocity,  $v_s/U$  on the dune steepness,  $h/\lambda$ , where  $v_s$  = seepage velocity in which a positive  $v_s$  denotes upward seepage and vice-versa;  $U$  = undisturbed mean flow velocity;  $h$  = dune height; and  $\lambda$  = wavelength of dune. These data appear to show that the dune steepness increases and decreases with suction and upward seepage,
