Conference Paper, Published Version

Final Stages of Butte City Bridge Erosion Control Project

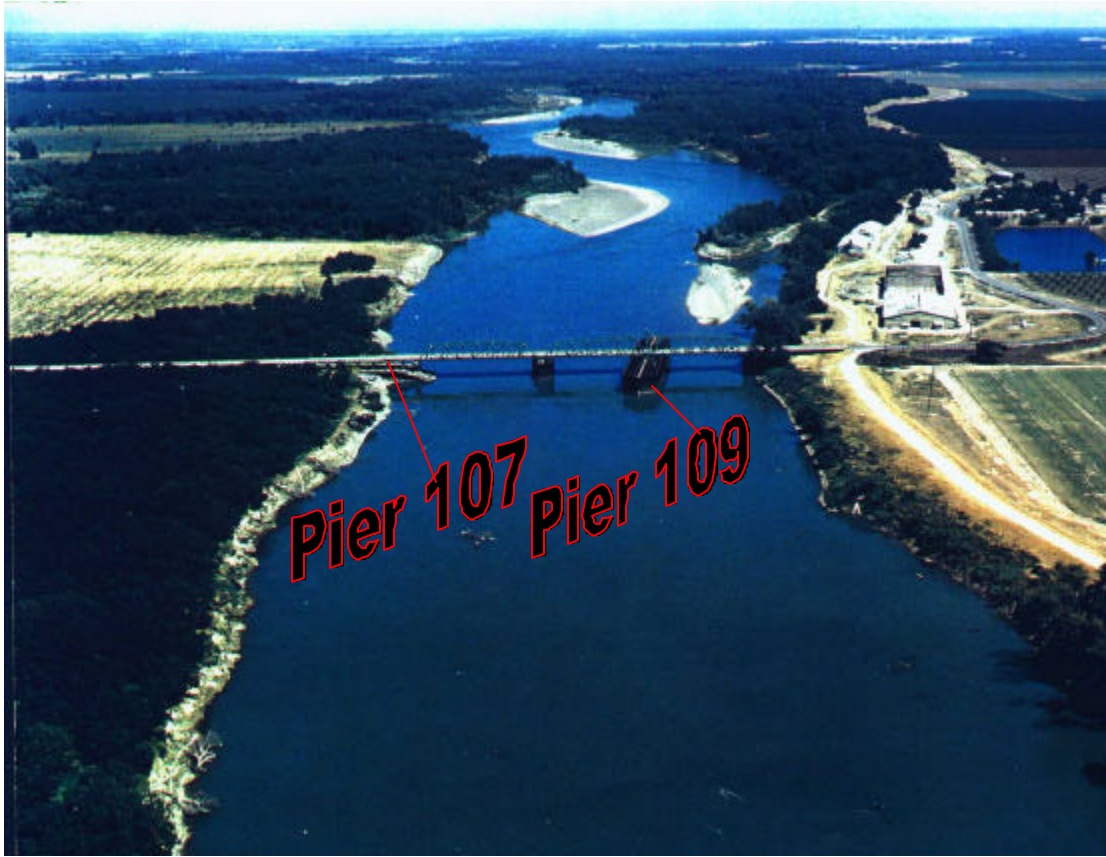
Figure 1: A bird's eye view of the bridge location

A bird's eye view of the bridge location is illustrated in the Figure 1. The length of the Butte City bridge is 1337.8 meters and it is supported by 111 piers and 2 abutments. The estimated flood with a return period of 100 years at this location of Sacramento River is about 6575 cubic meters per second. Pile exposure was noticed on the piers on the west side of the river after the 1992/1993 winter season. Figure 2 presents a view of the river just upstream of the bridge before the major floods of 1996/1997. The floods of 1996/1997 eroded about 6 meters of the riverbank rendering the piers 107, 106, and 105 scour critical (piers identified in Figure 1). Figures 3 and 4 illustrate the bank erosion caused by the floods of 1996 and 1997. Emergency repair work was conducted to prevent any additional damage to the affected piers which might have resulted in closure of the bridge. The repair work consisted of installing 18-meter-deep sheet piles with tie backs. The sheet piles were constructed to enclose and protect the bridge piers. In addition, rock slope protection was

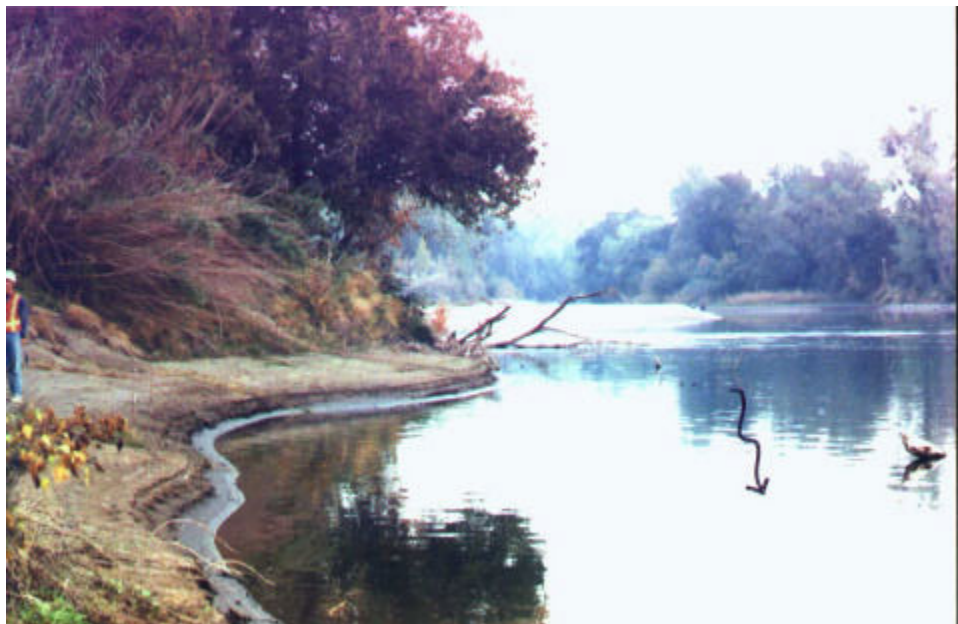
Figure 2: Upstream of the Butte City Bridge prior to the 1996/97 floods

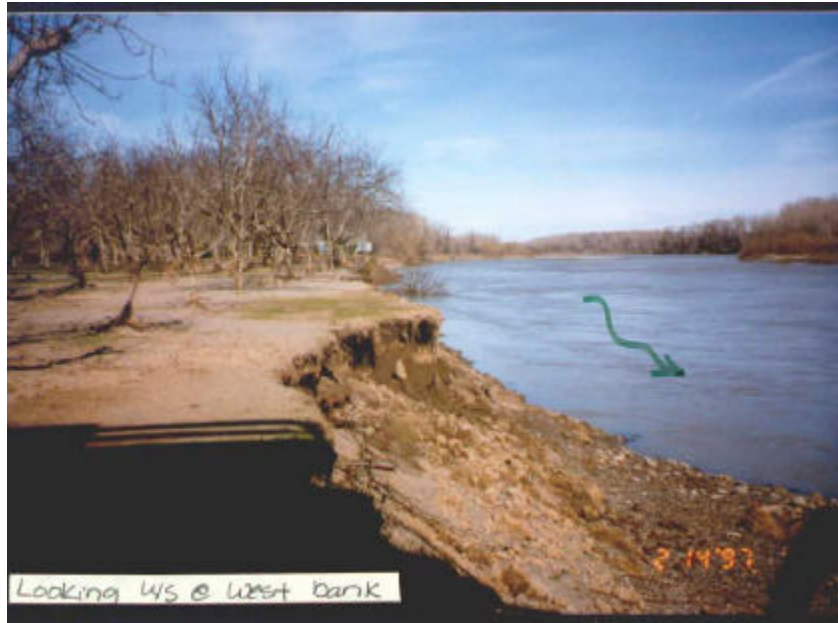
Figure 3: Erosion caused by the 1996/97 floods on the west bank

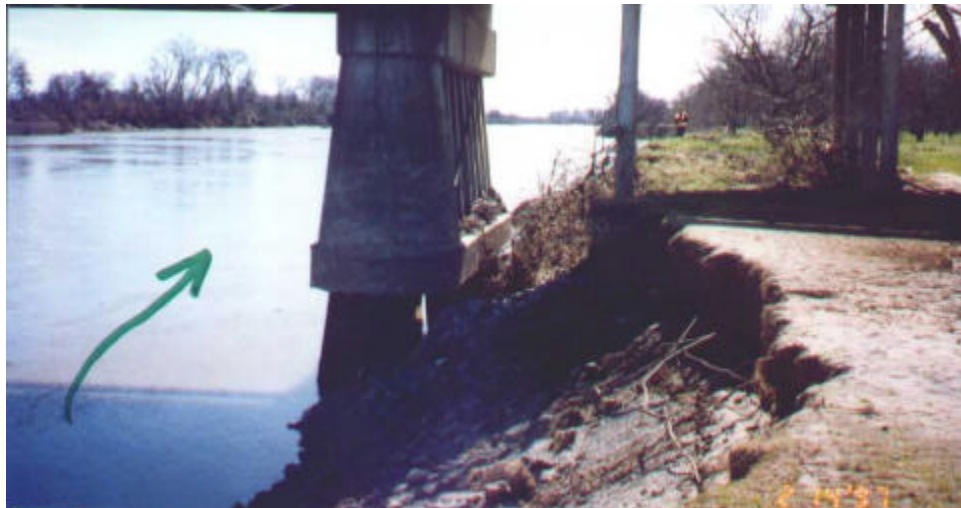
Figure 4: Scour caused by the floods of 1996/97 at pier no. 107

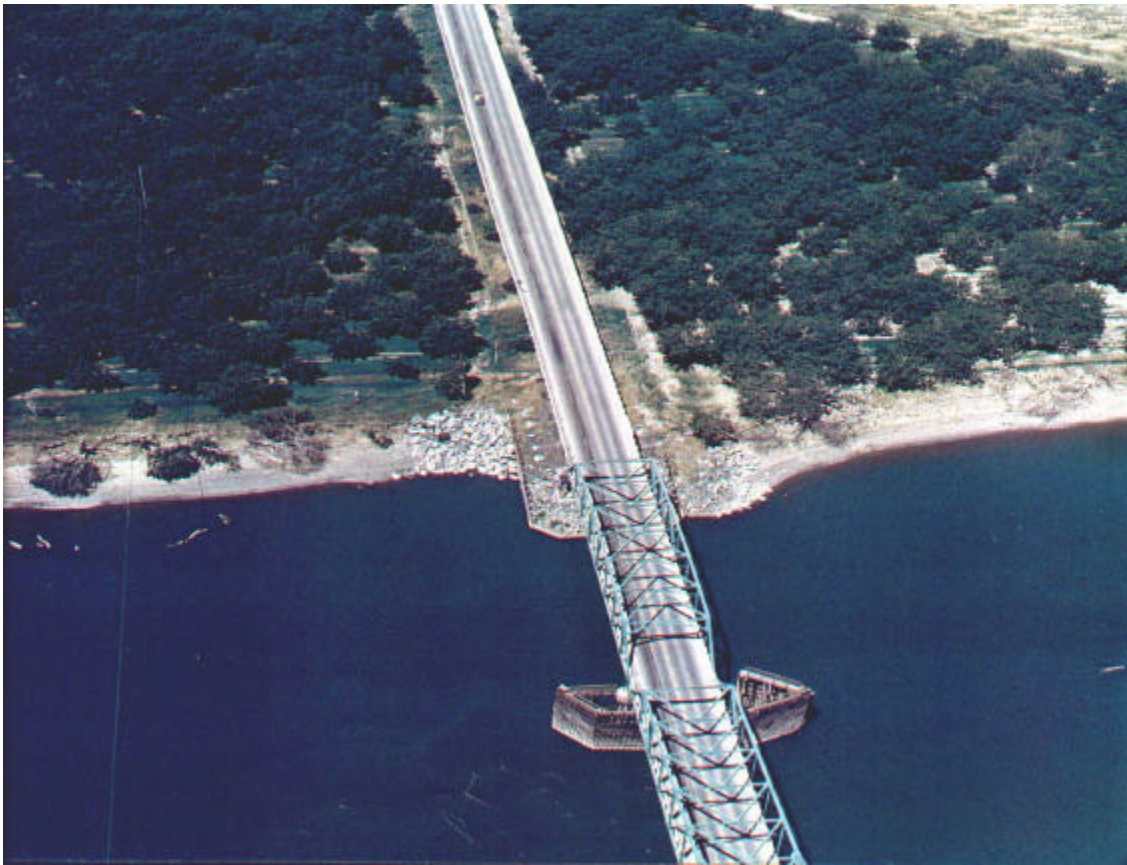
Figure 5: Repair work at pier 107 done in 1997

placed both upstream and downstream of the bridge to stabilize the embankments. Figure 5 shows the repair work done in 1997.

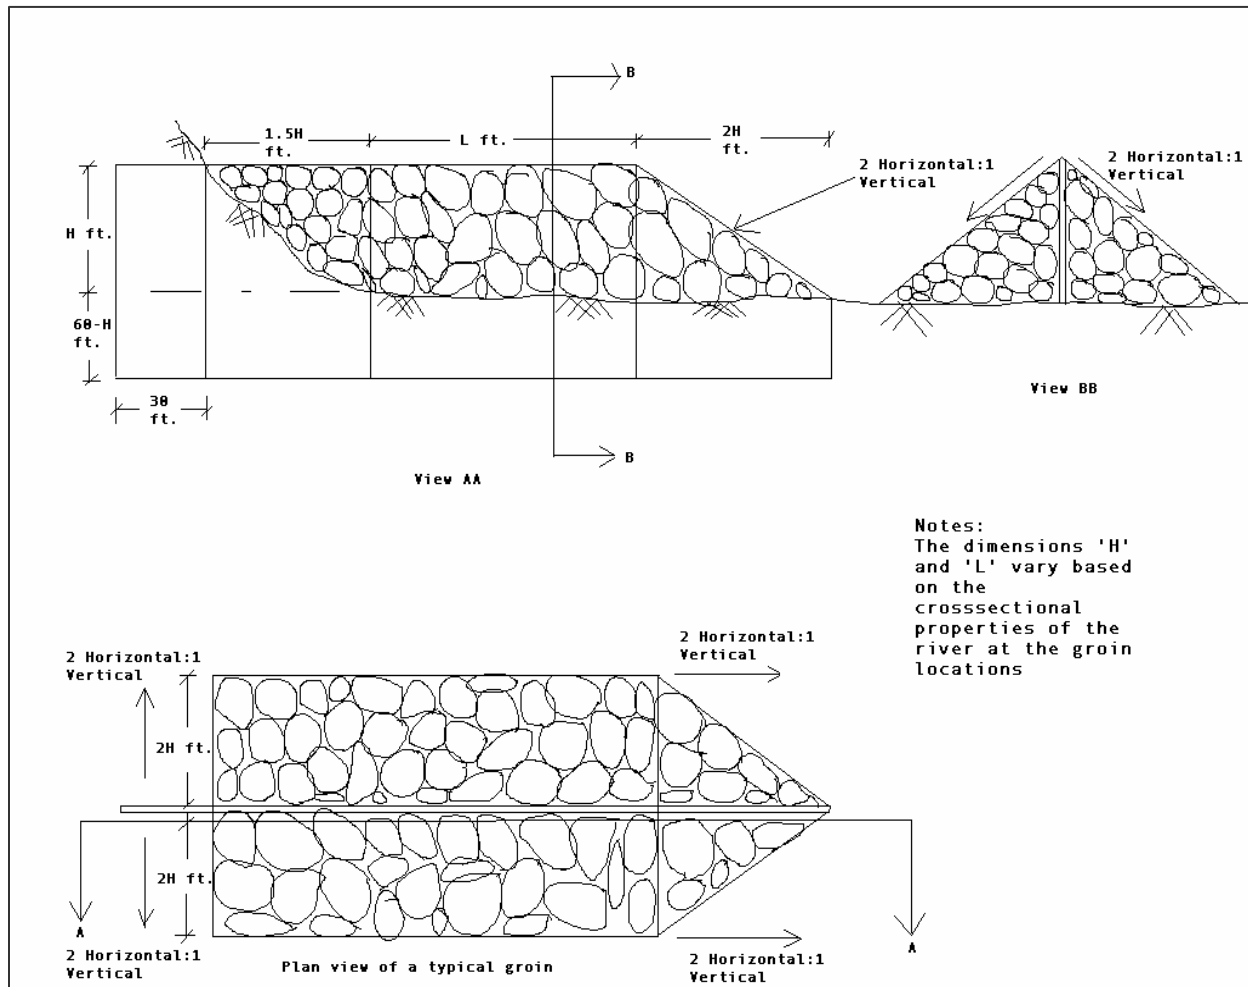
Figure 7: Detailed view of a typical groin
