Ranga-I Bridge Pier Scour In Bouldery Bed - A Case Study

BRIDGE PIER SCOUR IN BOULDERY BED - A CASE STUDY

RK DHIMAN

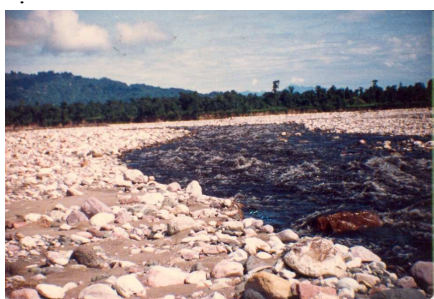
4 The size of the channel material is important at low velocity, the scour depth is less for a bigger size boulder since it is difficult for slow moving water to pick up and carry the larger size. This may eventually result in an armoured bed within the scour hole, slowing or stopping of erosion process until higher velocity scours the armored layer. Soil strata generally available in bouldery bed is indicated in Fig1 &2

Figure 1 & 2 soil strata in bouldery bed

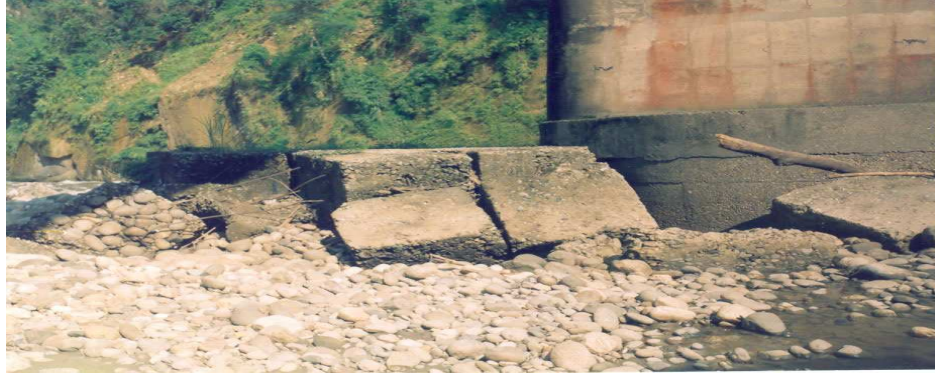
6 During Jun (1968) there was heavy flood with increased discharge about 1.6 times the designed discharge, affects the pattern of flow around the pier which was observed as oblique. This enhanced discharge caused heavy scour around the pier of central foundation and reoriented the flow on right channel only. Observations of scour was kept and bridge behaved well but from 1979 onward increased scour had been observed. Rehabilitation measures were taken after examination of the condition to arrest the scour. For this purpose concrete block were laid around the foundation as per practice in vogue. There had been instances when most of the concrete blocks made

around the pier were either washed away or dislocated due to water force. Scour remained within the designed limit.

To control the scour damage during past years PCC blocks were cast during the years 1981, 1984 and 1985. A few of these blocks got dislocated and later on all the blocks were interconnected. Under pinning of the blocks was also done. In fact the more damage was noticed due to oblique flow hitting the pier at angle and on left bank there was very less flow. There is sharp turn on D/S leading to sudden change in flow pattern. Detailed examination of the problem was done during 2000 keeping in view the past scour and rehabilitation measures taken so far. Following were observed (Fig.4) :-

- (a) Flow in the channel is oblique and maximum flow is going through the right side of the span.
- (b) All the PCC blocks need to be made matching with the bed level in order to avoid the obstruction of flow and to avoid formation eddies.

Fig 4 Scour around pier

7 Based on the observations of scour in past years, following recommendations were made :-

- (a) The river water be made to flow in the both the channel which is not happening at present as maximum discharge is going in the right side channel. This requires dredging of the river to some extent for left side span to pass the atleast 30% to 40% of discharge.
- (b) There is need of repelling type spur on U/S right side to ensure that further water flow stay to left channel equally.
- (c) Temporary arrangement made by PCC blocks to arrest scour be made in such a manner that top of block should match with existing bed level so that unnecessary obstruction is not caused to the flow and further scour is arrested.
