THANEERMUKKOM SALT WATER BARRIER TO PREVENT SALT WATER INTRUSION: AN OVERVIEW OF KUTTANAD LOW LAND DEVELOPMENT

BY THALLAK. G. SITHARAM & KOLATHAYAR SREEVALSA

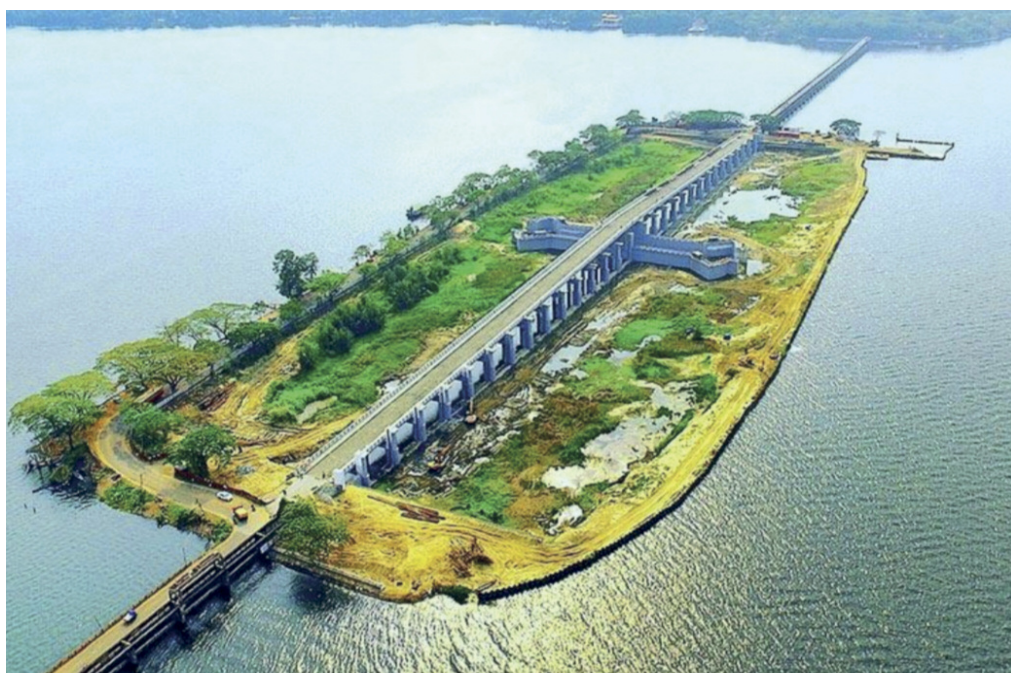
Figure 1. View of the Thaneermukkom bund

The Thanneermukkom bund has a length of 1400 m which includes a 470 m long stretch of reclaimed land at the centre of the bund. Construction began in 1955 but completion of the project took many years. The western and eastern portions of the bund have 31 shutters (gates) on each side. The construction of these parts was completed in 1967. Only two-thirds of the construction was complete by the year 1973. The remaining one-third was temporarily banded with sand and clay by mobilising local labour. Though incomplete, the regulator was commissioned by the end of 1974. In 1977, the government started building the middle section. The second phase at the Vechoor end was completed in 1974 with 31 shutters (gates) and one lock. A coffer dam was erected in 1975 when work of the third phase was delayed.
