Climate Change Adaption Strategies in Developing Countries – Exemplary Flood and Erosion Protection Projects in Mozambique

Dr.-Ing. H. Spekker & Dr. B. Kleinefeld
Inros Lackner SE, Linzer Str. 3, 28359 Bremen, Germany

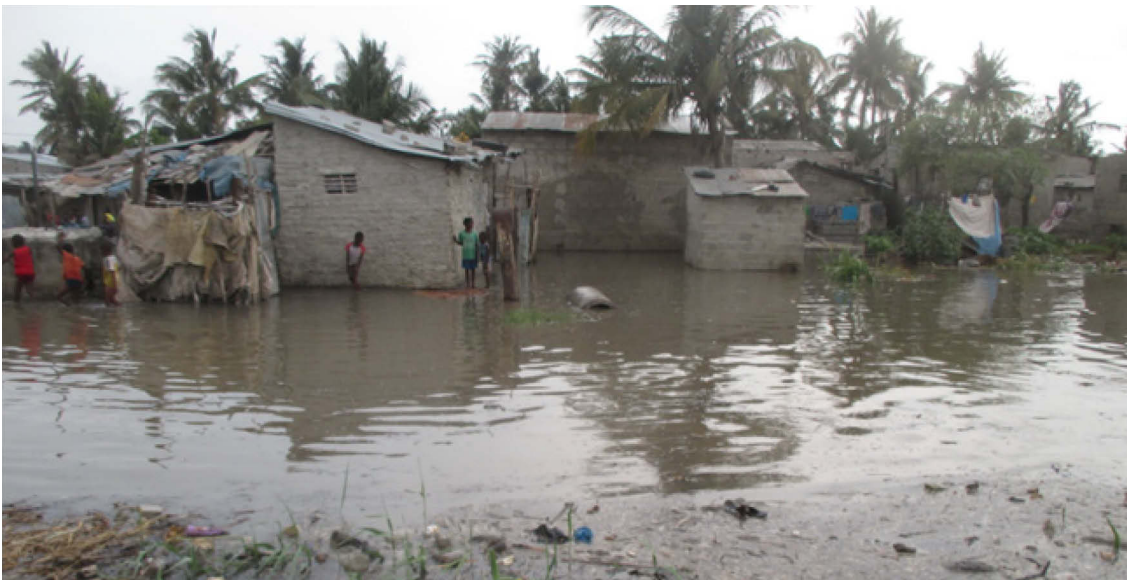
Fig. 1. Flooded area in the informal settlement Goto during the rainy season.

The Chiveve tidal river, which runs through the city of Beira over a distance of approximately 5 km, was neglected in the past and became increasingly silted up to the point that it no longer served as a drainage channel for the surrounding area. Rubbish was disposed of on the wetlands and the standing water promoted the spreading of diseases, such as malaria and cholera. During very high tides or storm surges in the adjacent ocean, combined with heavy rainfall, the Chiveve regularly overflowed its banks and flooded much of its catchment area – particularly the informal settlements along its riversides (see Fig. 1).

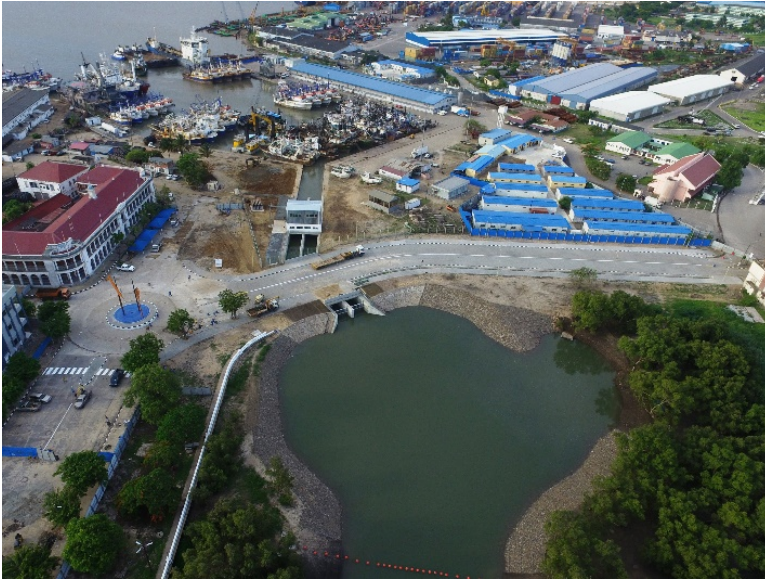
Fig. 2. Aerial photograph of the Chiveve river mouth including the new flood barrier.

As one major result of the project, a new flood barrier and new drainage channels (see Fig. 2 and Fig. 3), designed by Inros Lackner SE and Consulting Engineers Salzgitter GmbH are protecting the port city on Mozambique's Indian Ocean coast and improving the city's drainage since 2017.

The barrier's gates allow to control the water level upstream. Due to the construction of a retention basin and a precise control of the gates, the area's drainage system now functions far more effectively and thereby, the flooding situation along the Chiveve River was significantly improved. The barrier's effectiveness was put to the test at the end of February 2017, when approximately 225 mm of rain fell during a 24-hour period – a level of rainfall that, on average, is only expected once every ten years – and no significant flooding occurred in the project area. Moreover, after storm Desmond in January 2019, when approximately 355 mm of rain fell during a 24-hour period, no extreme water levels were measured upstream of the tidal gate, again.

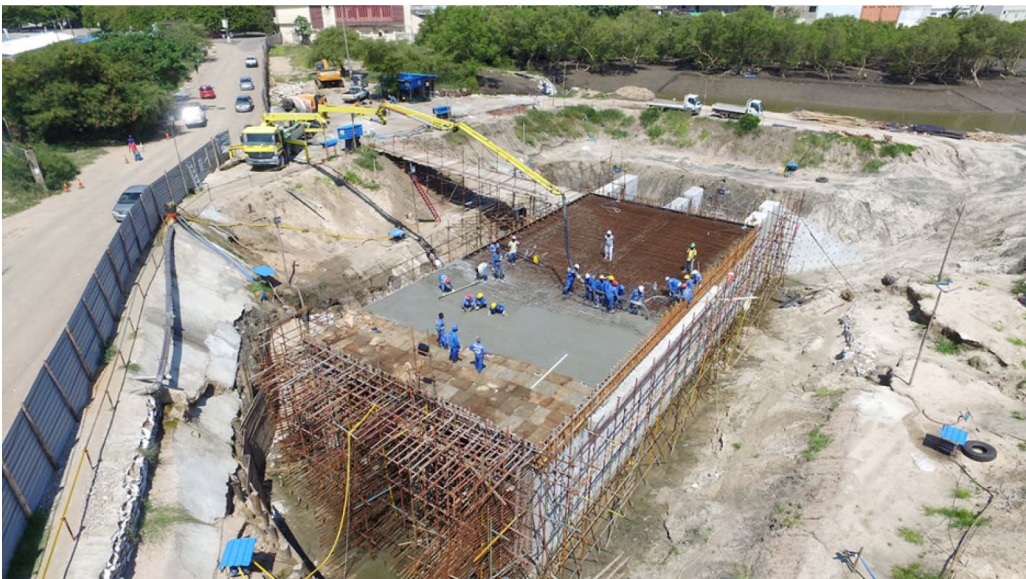
Fig. 3. Construction of the drainage channel upstream of the tidal outlet.

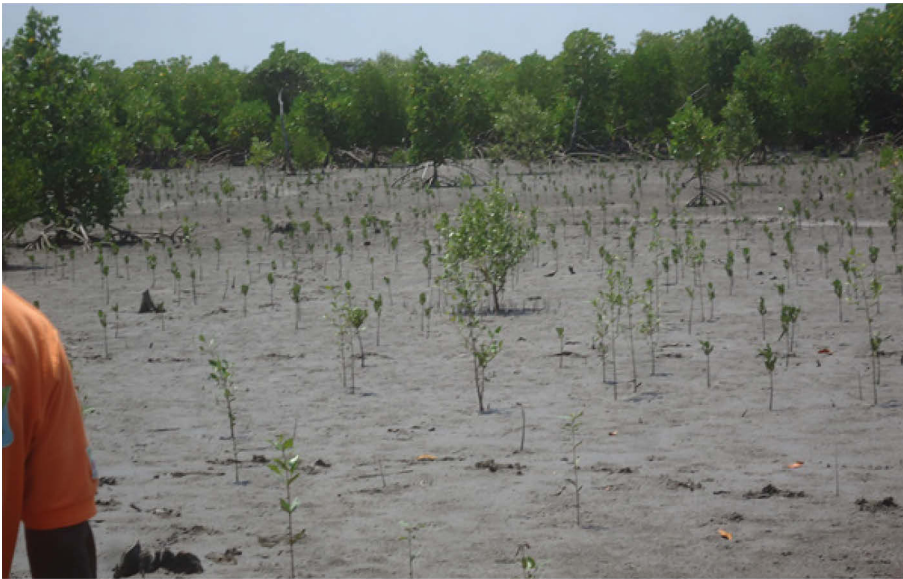
Fig. 4. Reforestation of mangrove forests in Nhangau.

The project also included a comprehensive plan for the reestablishment of the original course and nature-based erosion protection solutions along the embankments of Chiveve river. It also comprised dredging of sludge within the fishing port downstream, resettlement measures and the planting of young mangroves along the river banks, including a nearby coastal area (see Fig. 4).

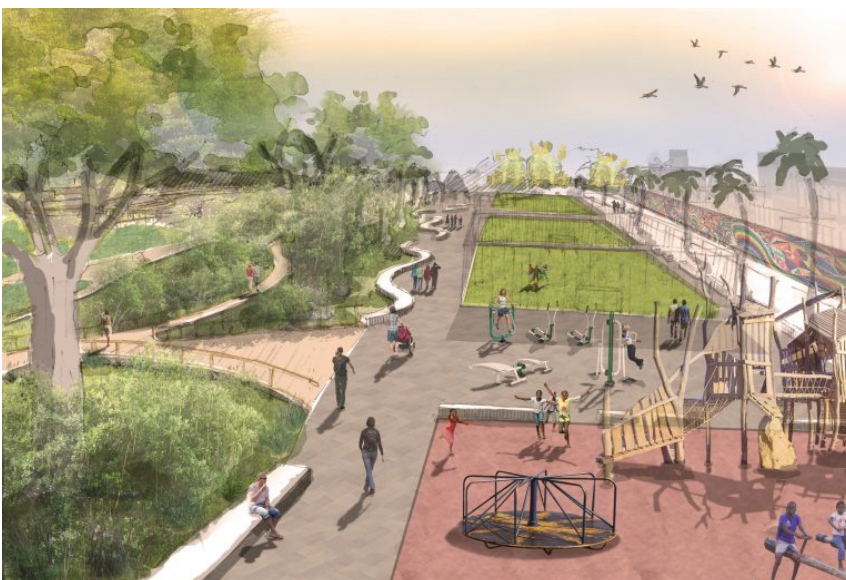
Fig. 5. Planned landscape development along the Chiveve River.

The green belt in the middle of the city centre is expected to protect the course of the river, which is lined with mangroves, from progressing urbanisation. It is developed to become a recreational area for the population, including restaurants, an exhibition centre and amphitheatre, a botanical garden, sports facilities and children's playgrounds. Over 7000 trees will be planted.

The green infrastructure is supported by the project through a grant from the Pilot Program for Climate Resilience, which aims to transform the Chiveve River margin areas into a green urban park that offers ecosystem services (biodiversity, drainage, urban cooling and flood mitigation), as well as economic and recreational opportunities to Beira citizens.

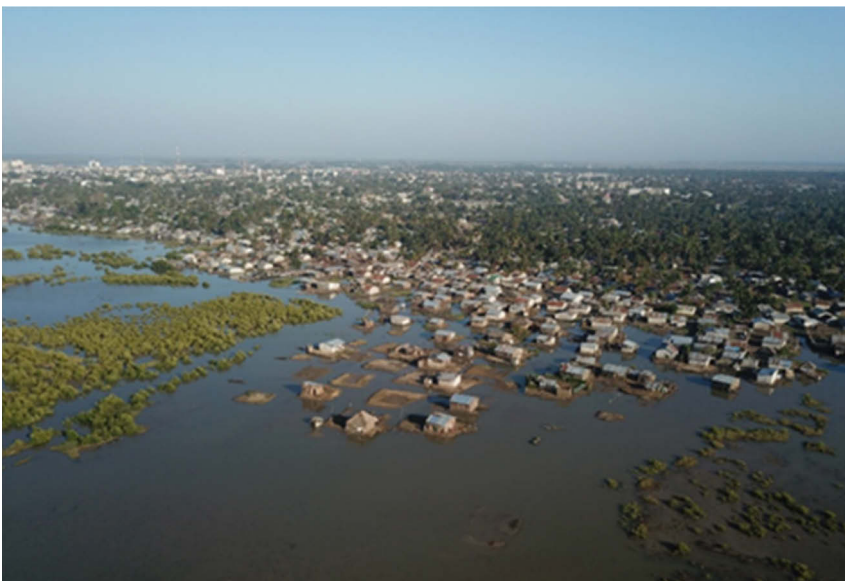
Fig. 6. Aerial photograph of informal settlements in Quelimane during high tide.

The main challenges in the City of Quelimane relate to flooding of infrastructure (houses, roads, airport, agricultural areas, etc; see Figure 6.), deforestation (which exacerbates the flooding), and lack of maintenance of the storm water infrastructure.

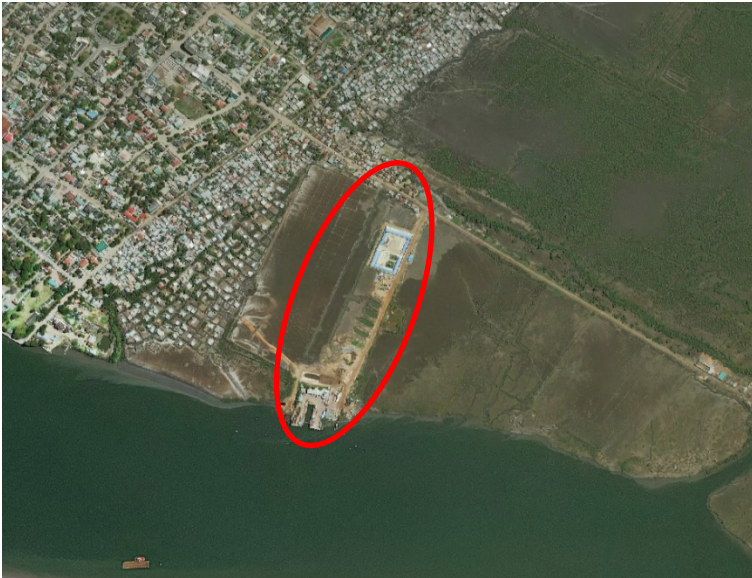
Fig. 7. Industrial development (within the red outline) in a wetland.

Houses, industries and road infrastructure are seen to be encroaching into areas of increasing flood risk. There appears to have been repeated encroachment of legal and illegal housing into high flood risk areas within the City, for instance into parts of the City that are inundated daily during spring tides. Industrial complexes have also been constructed within wetlands and river floodplains, leading to an increased risk of flooding of these areas. In addition, the proliferation of buildings, industries and roads in the City has led to hardening of the catchments, through soil sealing, and this has the direct result of changing the hydrology (i.e. the volume, velocity and frequency) of surface flow throughout the City. This may contribute to flooding, and may exacerbate the lack of capacity of the storm water management system.

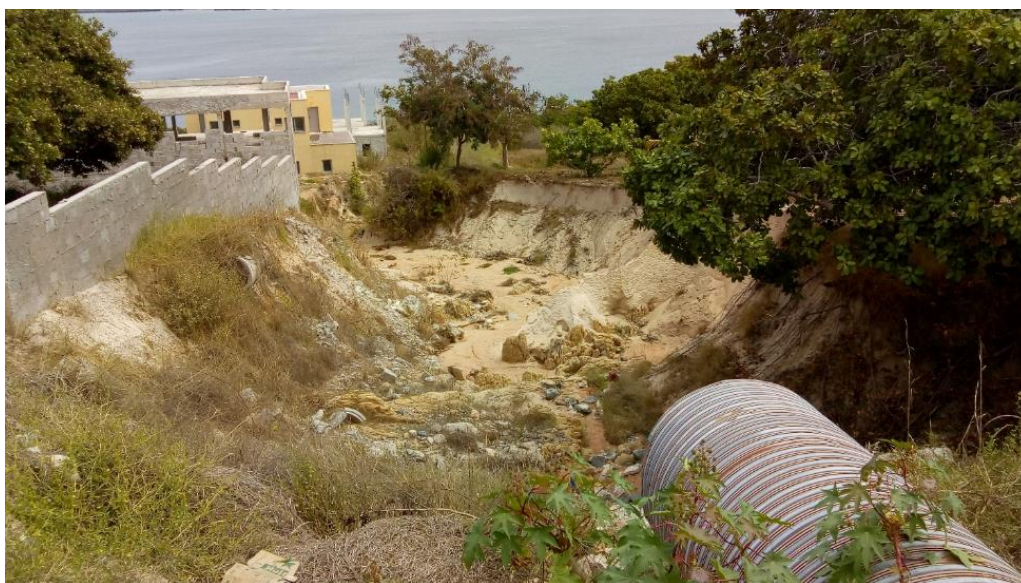
Fig. 8. Erosion due to storm water runoff in Nacala City.

Although heavy rainfalls do not lead to large-area flooding, rainfall induces very concentrated runoff forming multiple gullies which dispose the rainfall towards the sea. The Mayor of Nacala has even warned that erosion in the city is becoming alarming and may even threaten the future of Nacala as a deep-water port as there is a danger that one day these deep waters may cease to exist because of the sediments accumulating in the access channel and in the port itself.

Due to the high flow velocity and high bed shear stress the gullies tend to deepen every year. This leads to collapsing side slopes and the disposal of this material which results in growing – relating to their width – gullies.
