Failure Mechanisms of Riprap Layer around Bridge Piers

Yee-Meng Chiew¹

ABSTRACT

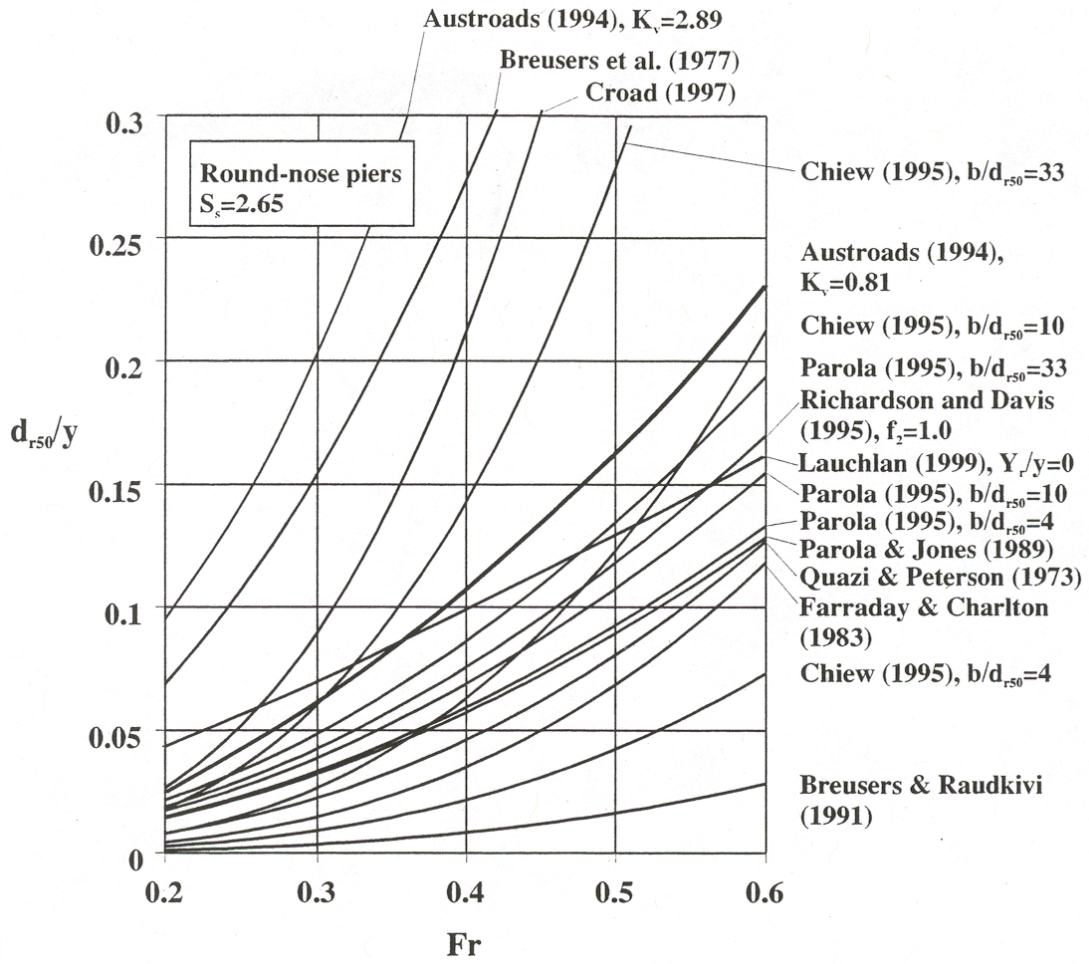
Figure 1. Comparison of Equations for Sizing Riprap at Bridge Piers
(Melville and Coleman 2000)

Shear failure of a riprap layer around a bridge pier refers to the entrainment of the riprap stones by the local flow field. This occurrence simply means that the stones are not large or heavy enough to withstand the downflow and horseshoe vortex associated with the pier-scour mechanism for the given flow condition. Among all the five failure mechanisms outlined above, this is the easiest to conceptualize as one can clearly see the entrainment of individual stones in a laboratory experiment. For this reason, it is the most studied of all the failure mechanisms. To-date, there are a host of formulas available for use by bridge engineers seeking to find the appropriate riprap stone size. Lauchlan (1999), in her doctoral dissertation, compiled a list of these published equations and compared their performance. Some of these equations and their comparisons, which are also shown in Melville and Coleman (2000), are reproduced in Table 1 and Figure 1, respectively.

A comparison of these 12 equations was done by Lauchlan (1999), and is reproduced in Figure 1. Although researchers in the area of the pure sciences may be appall with the lack of consistency of the data, researchers in sediment transport area is not unfamiliar with such variations. In fact, when compared with other sediment transport predictive equations, the bulk of the equations do give reasonably consistent results.

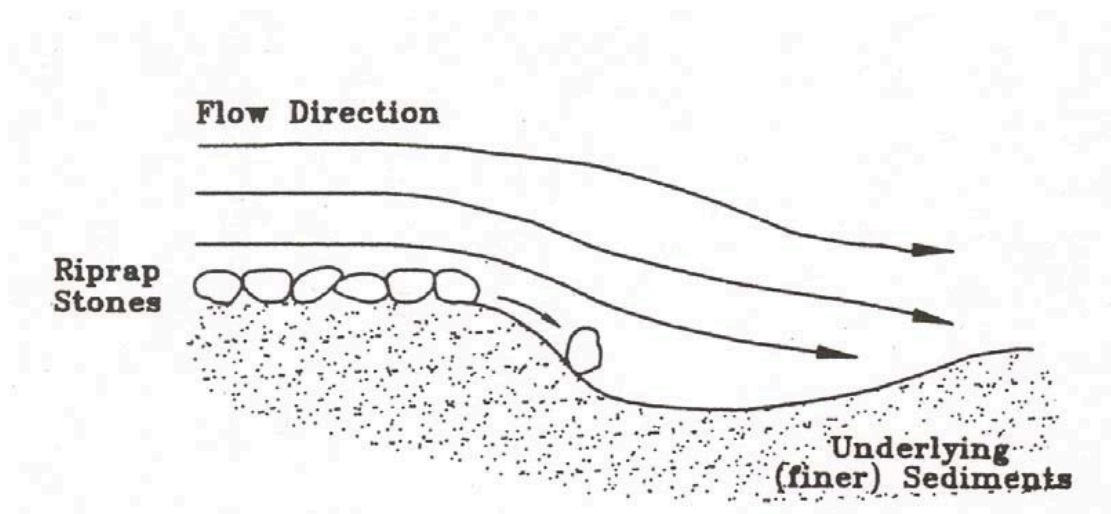
Figure 3. Schematic Illustration of Edge Failure (Chiew 1995)

The third type of failure associated with riprap protection around bridge pier is edge failure. This occurs at the periphery of the coarse riprap stones and fine bed sediment interface. Chiew (1995) first documented this type of failure, and attributed it to the increase in shear stress on the finer sediment bed as water flows from the coarse to the fine bed boundary. It is not uncommon in flume experiments involving a rigid-loose bed interface. At such a location, a scour hole inevitably forms on the downstream erodible bed.

With riprap protection around a bridge pier, edge failure can occur when the coarse riprap stones remain intact; i.e., they can resist shear failure. With the intact riprap layer in place, the downstream finer sediment particles are entrained by the flow because of their lower critical shear stress. When this happens, a local depression forms, exposing the larger riprap stones. The stones at the edge thus roll or slide into the depression, as illustrated in Figure 3. Chiew (1995) observed the occurrence of edge erosion at the downstream end of the riprap layer. Such erosion takes place at low velocity ratio where shear

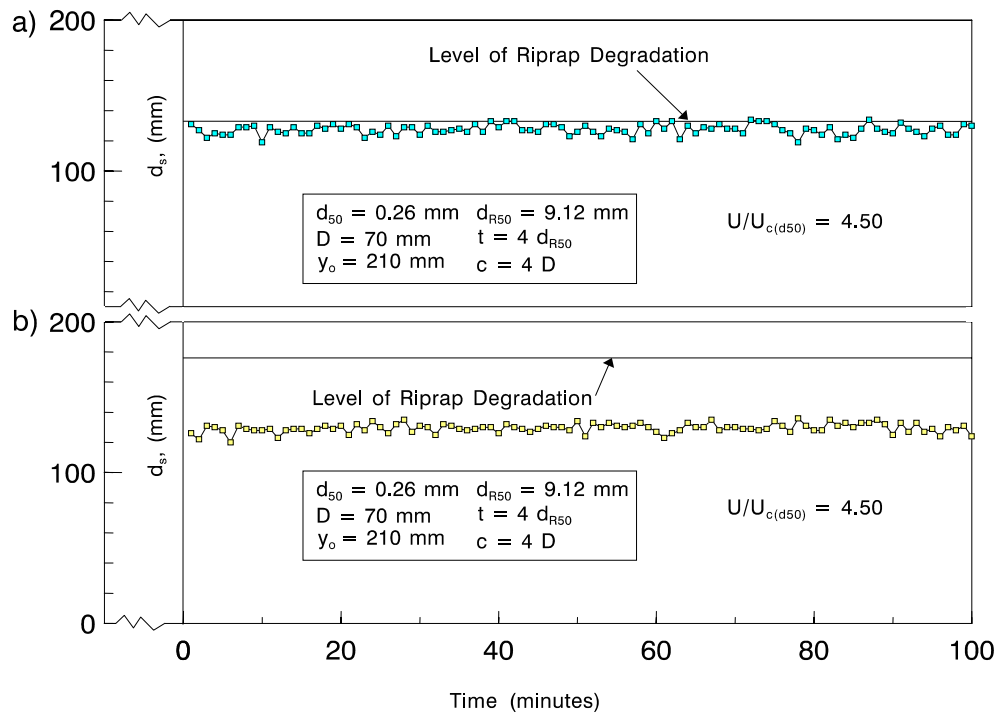
Figure 4. Temporal Variation of Scour Depth in Transition Flat Bed Regime with Different Antecedent Bedforms: (a) Immobile Plane Bed; (b) Immobile Plane Bed, Ripples and Dunes (Chiew and Lim 2000)

Chiew and Lim (2000) have also devised an experiment to distinguish bedform-induced failure from the other three types of failure. It includes two tests which were both conducted under transition flat bed conditions at a velocity ratio, $U/U_c = 4.5$. All the other conditions for both the tests were identical except that in the first test, the flow velocity was increased as quickly as practicable so that transition flat bed was formed immediately after the onset of the test. The objective of such a procedure was to avoid the formation of ripples or dunes on the approaching bed so as to negate any bedform-induced failure at the riprap layer before the test was conducted. With the second test, velocity was increased incrementally to allow ripples and dunes to form prior to the final test with $U/U_c = 4.5$.

Figure 4 shows the results of the two tests, and it depicts the temporal scour depth fluctuation at $U/U_c = 4.5$ where transition flat bed was present on the approaching bed. The horizontal lines in Figures 4(a) and 4(b) represent the depth of the riprap layer – the level at which the riprap layer has degraded. The results show that the levels of riprap degradation, d_{rp} for Test 1 and 2 are 133 mm and 176 mm, respectively. In Test 1, the scour depth expectedly fluctuates with time and it is due to avalanches of the sediment particles on the upstream slope of the scour hole. It shows that the riprap layer has clearly degraded to the same level as the maximum scour depth. On the other hand, d_{rp} associated with Test 2 is deeper than the observed maximum scour depth at $U/U_c = 4.5$. The reason for the deeper d_{rp} is because of the antecedent condition where ripples and dunes were allowed to form before the later test was conducted. The differential of 43 mm (difference between 176 and 133 mm) is caused by bedform-induced failure.

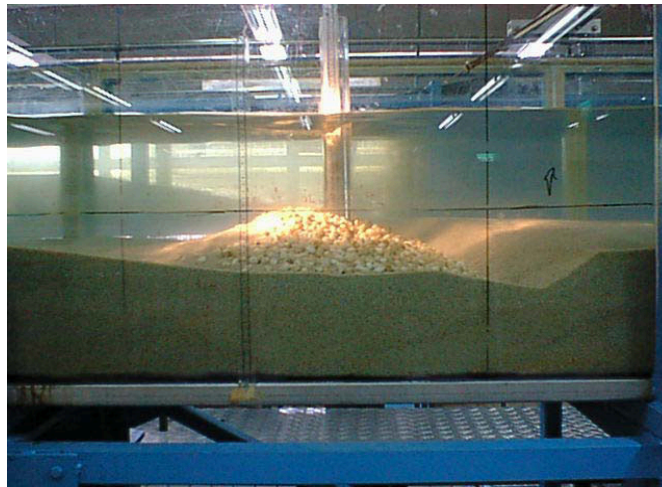
Figure 5. Formation of riprap mound around bridge pier in a degrading bed (Flow from right to left)

The cumulative effect of these two features is the formation of a stable mound consisting of riprap stones around the bridge pier, as is shown in Figure 5. Chiew (2002) further showed that the riprap mound might be susceptible to failure when it is subjected to another flood accompanied by large dunes.

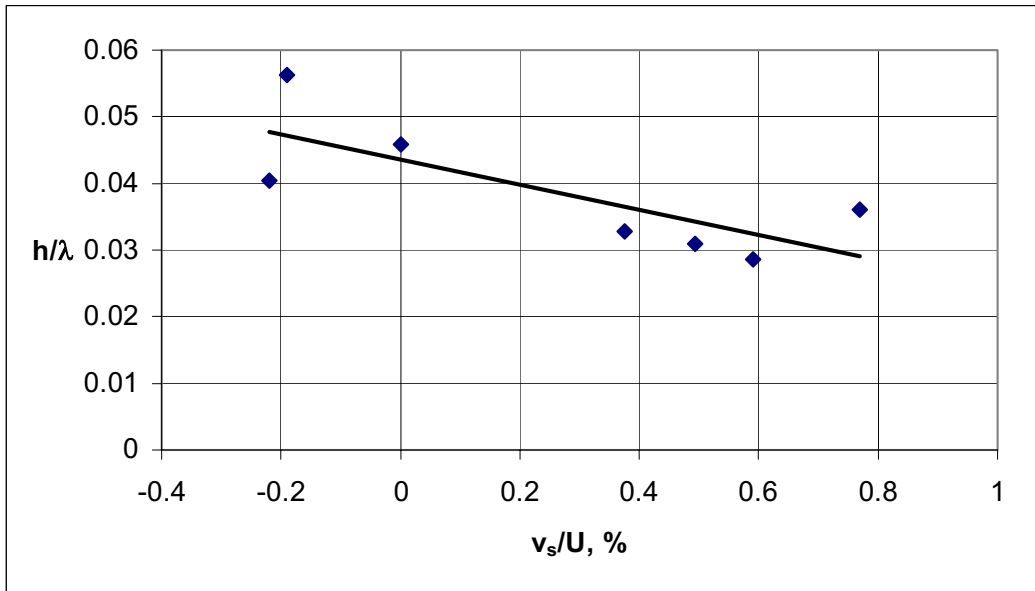
Figure 6. Effect of relative seepage velocity on dune steepness

To this end, the present writer has conducted some very preliminary studies on seepage effect on dune geometry. These data are encouraging in that the dune geometry does appear to change as bedforms translate past a region subjected to upward seepage or suction. Previous studies on both seepage and suction (Cheng and Chiew, 1998; 1999 and Chen and Chiew, 2001) have shown a close correlation between such flows on the turbulence characteristics of the main flow field. This, in turn, affects the sediment transport behavior of the river. It, therefore, would not be inappropriate to surmise that either seepage or suction could have a positive influence in reducing the size of the dunes. Figure 6 shows the preliminary results of the effect of relative seepage velocity, v_s/U on the dune steepness, h/λ , where v_s = seepage velocity in which a positive v_s denotes upward seepage and vice-versa; U = undisturbed mean flow velocity; h = dune height; and λ = wavelength of dune. These data appear to show that the dune steepness increases and decreases with suction and upward seepage,
