Uchimura, Taro; Towhata, Ikuo; Lin, Wang; Seko, Ichiro
Simple and Low-Cost Early Warning System for Slope Failure due to Rainfall and Erosion

Uchimura, Taro; Towhata, Ikuo; Lin, Wang; Seko, Ichiro (2008): Simple and Low-Cost Early Warning System for Slope Failure due to Rainfall and Erosion. In: Sekiguchi, Hideo (Hg.): Proceedings 4th International Conference on Scour and Erosion (ICSE-4). November 5-7, 2008, Tokyo, Japan. Tokyo: The Japanese Geotechnical Society. S. 661-664.

SIMPLE AND LOW-COST EARLY WARNING SYSTEM FOR SLOPE FAILURE DUE TO RAINFALL AND EROSION

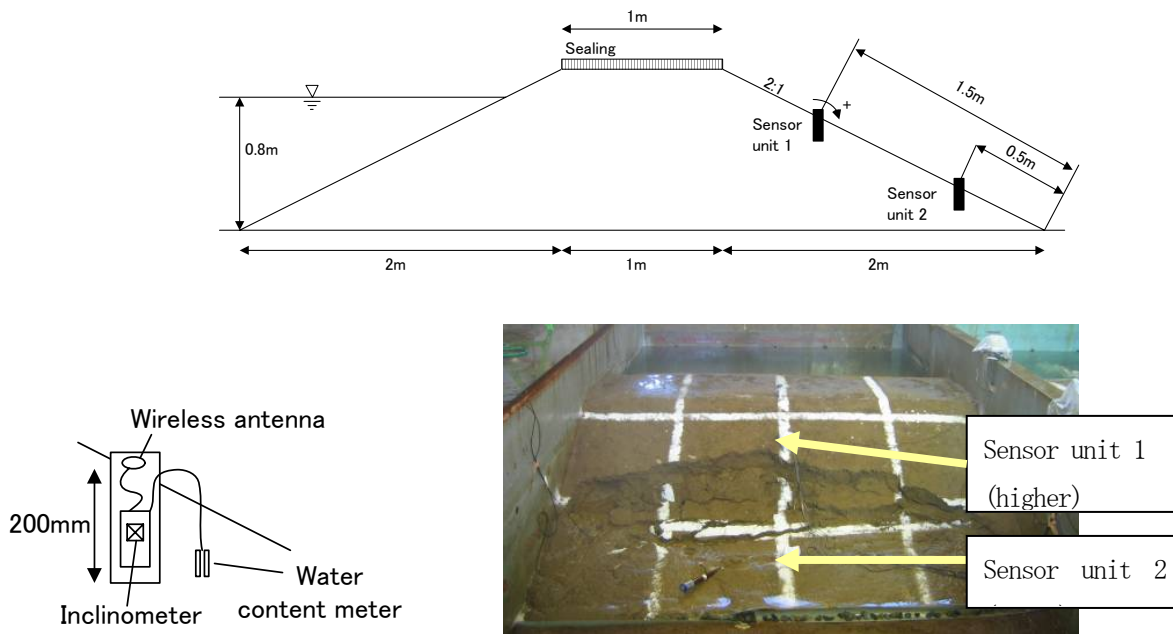
Figure 1. Arrangement of slope model and sensor units for the test 200

In 2006, the authors developed prototypes, and tested them on a 1 m-high model sandy slope under artificial heavy rainfall, whose test was conducted by Public Work Research Institute (PWRI), Tsukuba, Japan (Figure 1). The slope model had a gradient of $H=2 : V=1$, and it was made of a compacted sandy material ($D_{max} = 4.57\text{mm}$, $D_{50} = 0.17\text{mm}$, $F_c = 14.3\%$, $G_s = 2.69$, $\rho_d = 1.37 \text{ g/cm}^3$, $D_r = 80\%$), and its initial water contents was 19%. After filling water on the back side of the slope to simulate a situation of river dike, an artificial continuous rainfall of 15 mm/h was given. Two sensor units, equipped with an inclinometer and a volumetric water contents meter, were installed on the slope as shown in Figure 1. The installation work was simple, just embedding the unit and the attached water content meter on the slope to a depth of 20 cm, taking less than 30 minutes for each unit. As the power saving techniques were not completed at this time, the power for the sensor units were supplied by cables, but the data was sent to the gateway wirelessly, and recorded every 1 minute. The radio communication worked properly even in heavy rainfall conditions.

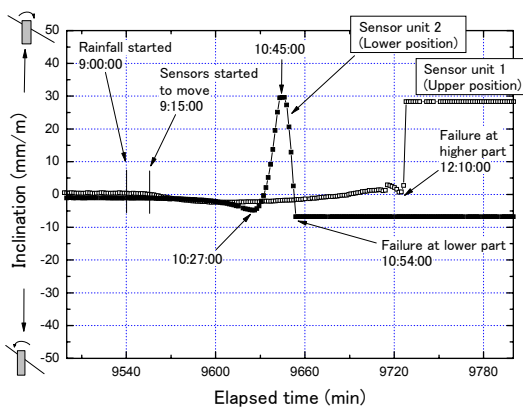
Figure 2. Behaviours of inclination for the test 2006. Figure 3. Behaviours of water contents for the test 2006.

Figure 2 shows the behaviours of the inclination and water contents at each sensor unit. The slope failure was progressive starting from the toe, and the lower part with sensor unit 2 was failed around 2 hours after starting rainfall. The inclination showed extraordinary behaviours 30 minutes before that. Such behaviour could be used as a signal for early warning. However, the upper part around the sensor unit 1 was failed after 3 hours of rainfall, but the behaviours of the inclinometer were not clear as the lower part. The behaviour of inclination before failure is case-by-case, and thus, criteria to issue warning should be defined carefully.

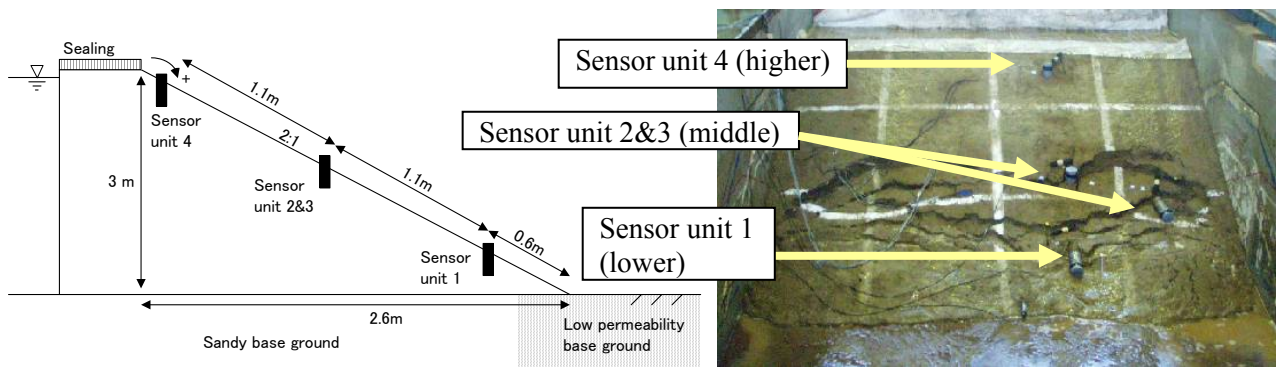
Figure 4. Arrangement of slope model and sensor units for the test 2007.

Figure 4 shows the arrangement of the model and the sensor units. The slope is 3 m-high with a gradient of $H=2 : V=1$, and made of the same material

as the previous slope. Four sensor units were installed at the three different levels on the slope (two of them were at the middle height with some horizontal distance).

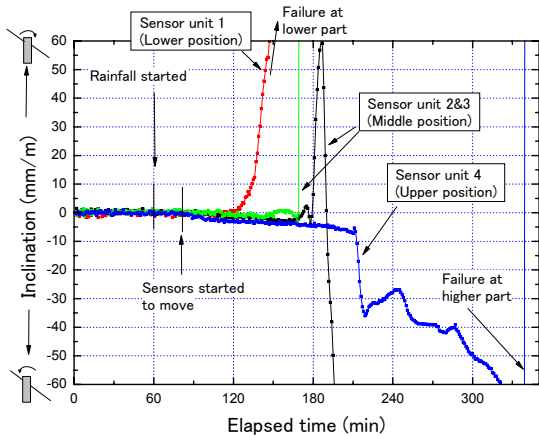
Figure 5. Behaviours of inclination for the test 2007.

Figure 5 and 6 show the behaviours of inclination and water contents at each unit, respectively. Again, some gradual changes in inclination were observed more than 30 minutes before the failure at each unit position, but their behaviors are not constant.

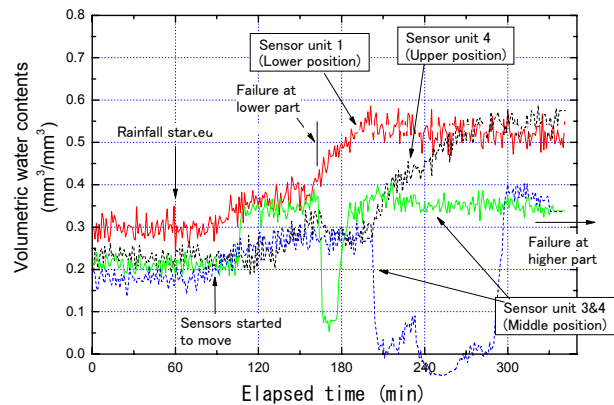
Figure 6. Behaviours of water contents for the test 2007.

The volumetric water contents were also below the level of saturation before failure, but they suddenly decrease or increase after failure. These behaviours of water contents may be due to cracking in the soil around the sensors. When the soil is detached from the surface of sensors, low water contents are observed. And if the crack around the sensor is poured with water, the measured water contents show higher values than saturation.
