# THANEERMUKKOM SALT WATER BARRIER TO PREVENT SALT WATER INTRUSION: AN OVERVIEW OF KUTTANAD LOW LAND DEVELOPMENT

BY THALLAK. G. SITHARAM & KOLATHAYAR SREEVALSA

The Thaneermukkom salt water barrier bund was constructed in 1974 to prevent tidal action and intrusion of salt water into the Kuttanad low land across the Vembanad Lake in Kerala, India. This bund divides the Vembanad lake into two, Thaneermukkom in the south with fresh water fed by the rivers draining into the lake and Vechur in the north with brackish water fed by the Arabian Sea. This bund creates a fresh water storage reservoir by storing river flood water, which has helped the farmers in Kuttanad, where farming occurs below sea level. The gates of the bund are opened during the monsoon period and are closed after approximately six months. This article reviews the present status of the Thaneermukkom reservoir and provides suggestions for tackling its environmental and ecological problems such as the pollution of the backwaters and the entire land nearby and the rampant hyacinth growth in the freshwater reservoir.

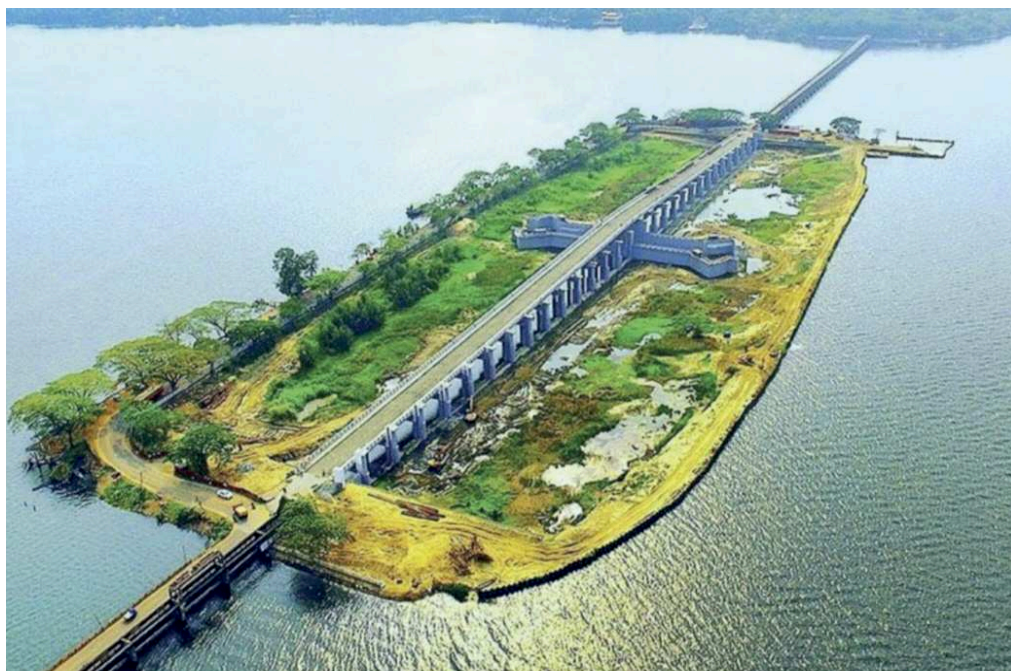
Figure 1. View of the Thaneermukkom bund

The Thanneermukkom bund has a length of 1400 m which includes a 470 m long stretch of reclaimed land at the centre of the bund. Construction began in 1955 but completion of the project took many years. The western and eastern portions of the bund have 31 shutters (gates) on each side. The construction of these parts was completed in 1967. Only two-thirds of the construction was complete by the year 1973. The remaining one-third was temporarily banded with sand and clay by mobilising local labour. Though incomplete, the regulator was commissioned by the end of 1974. In 1977, the government started building the middle section. The second phase at the Vechoor end was completed in 1974 with 31 shutters (gates) and one lock. A coffer dam was erected in 1975 when work of the third phase was delayed.
